## **RESHEALIENCE**

***Rethinking coastal defence and  
Green-energy Service infrastructures  
through enHancEd-durAbiLity  
high-performance cement-based materials***

***D3.1 – Definition and description of the scenarios for WP8  
pilots***

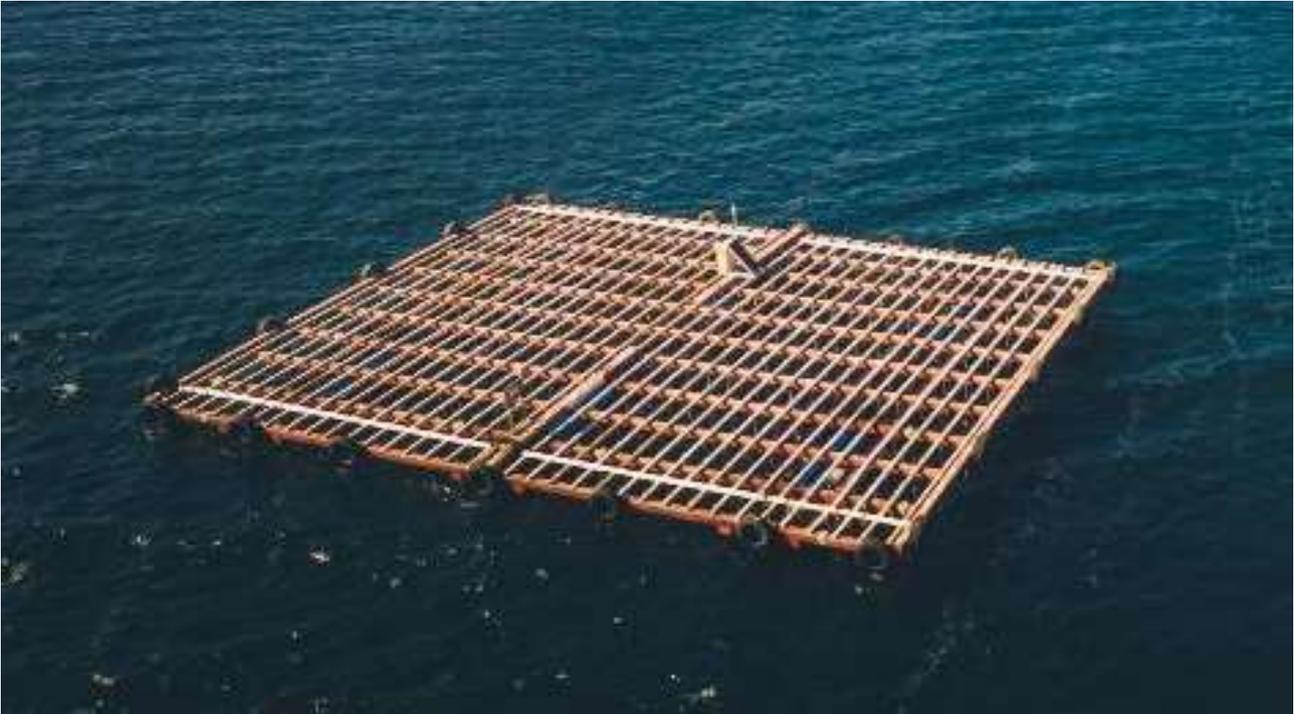
**Figure 3.2. RDC floating platform**

*Type of element:* Floating platform (5 of them, the first one floated in October 2016). Produced by IDIFOR.

At this moment there is no pathology observed. The sensors installed by the IDM in three of the rafts indicate a very low risk of corrosion and that the corrosion phenomena has not started.

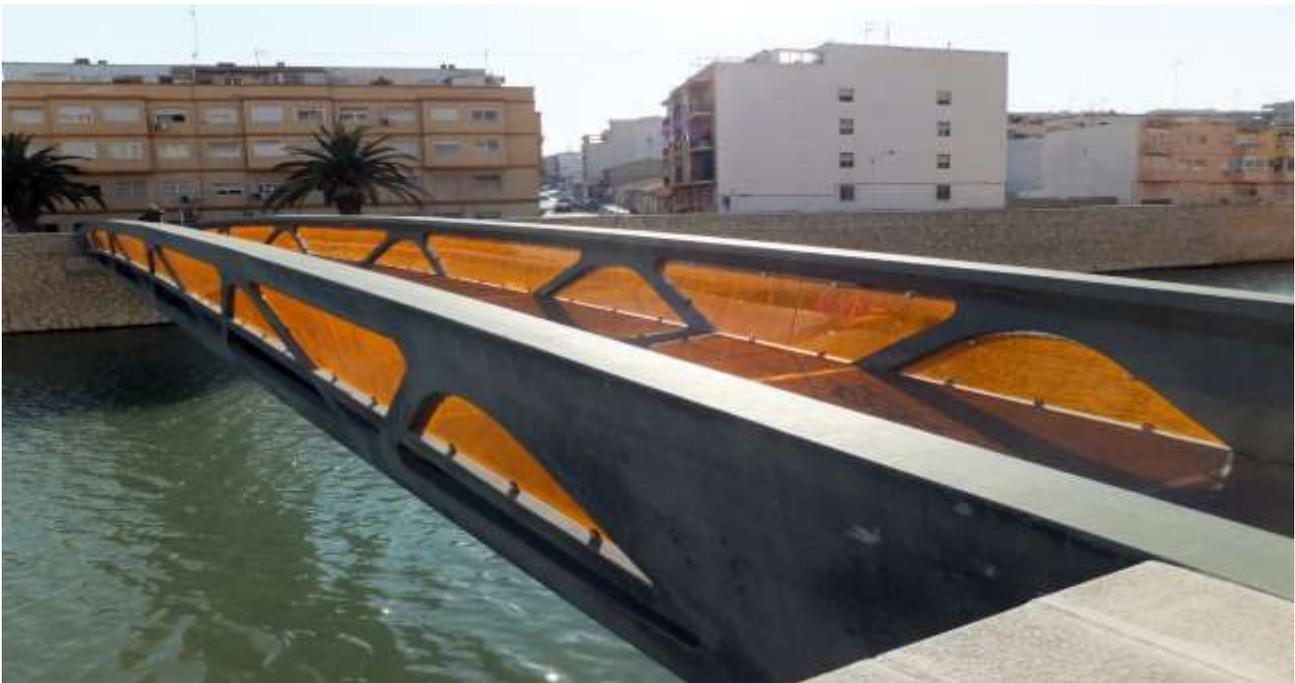
**Figure 3.3. RDC pedestrian bridge**

Footbridge in Alicante. Designed by the current members of RDC, produced in PREVALESA.

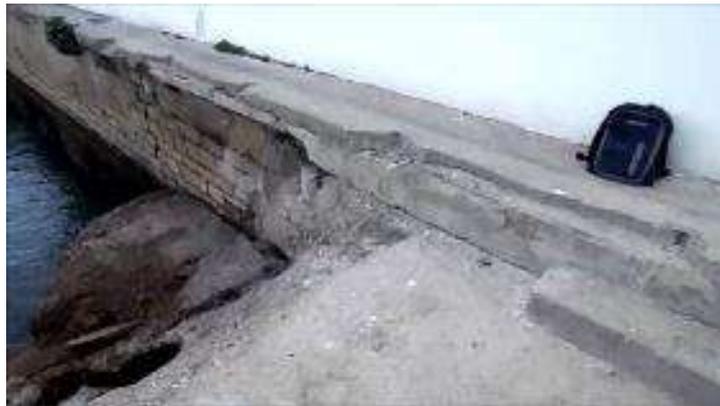
*Figure 4.1. Degradation of the concrete slab*

Several pathologies in the docks of Casablanc Port (Figure 4.1 to Figure 4.3) have been highlighted and studied related to concrete - steel degradation produced by several effects: mechanical actions, concrete wear, reinforcement corrosion, cracking, insufficient coating, etc. These pathologies require repair to avoid aggravation. The situation of unusable or inefficient defences, which can cause damage to concrete in an indirect way because of failure to provide the necessary protection is also shown.

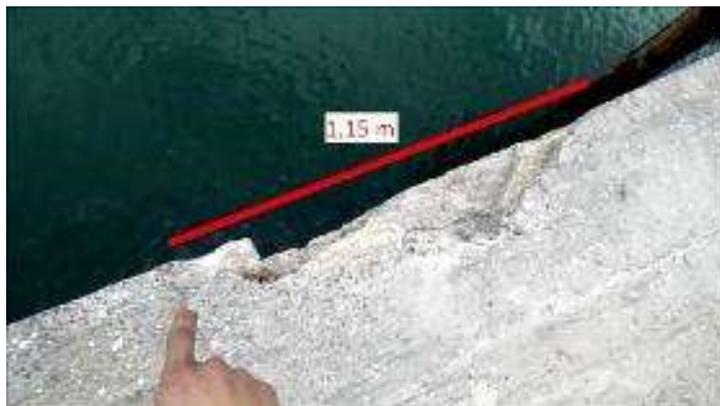
*Figure 4.2. Spalling*

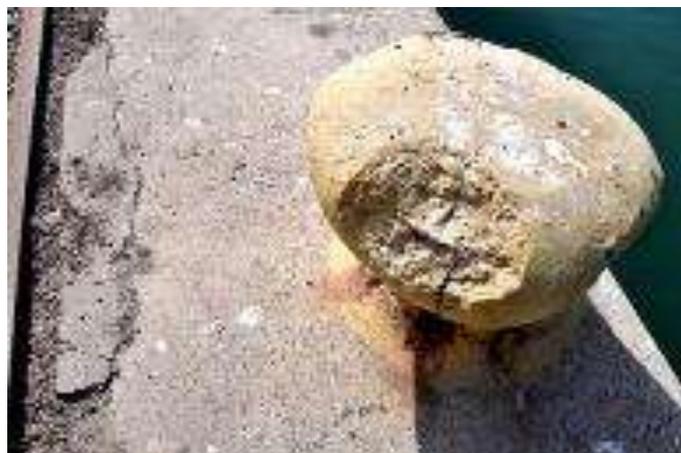
*Figure 4.3. Bollard of damaged concrete*

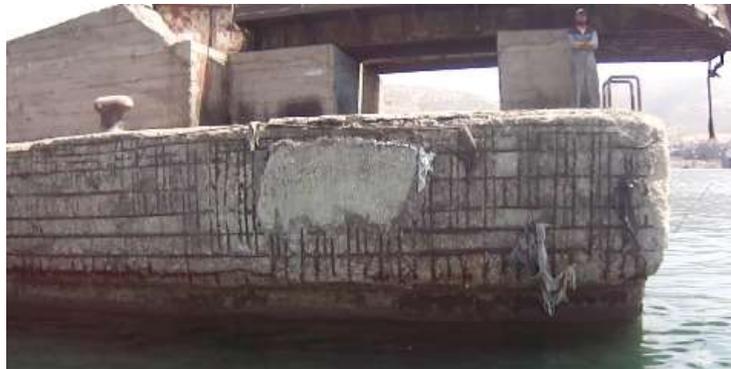
*Figure 4.5. Carbonation and corrosion*

Most of the forehead of docks is severely damaged (Figure 4.5). The majority of the surface of the front side of the slab is affected by carbonation of the concrete, exposing the reinforcement. The second most important degradation consists of breakdowns, failure or lack of adequate defences to the stressed induced by the berthing of ships. This degradation will lead to mechanical breakdowns of in the concrete.

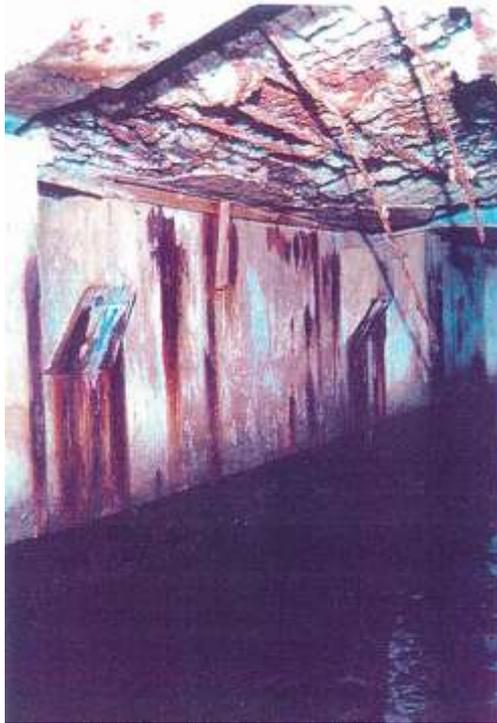
**Figure 4.6. Block of cantile beam**

The possible cause of damage in the lower side of the slab can be the following: the air under the slab is not easily renewed since the tidal range is very short in Valencia. Water condensation is boosted by temperature variations between night and day, creating an aggressive airborne environment. In such a situation ventilation is important in order to avoid corrosion since it will help to reduce the water condensation.

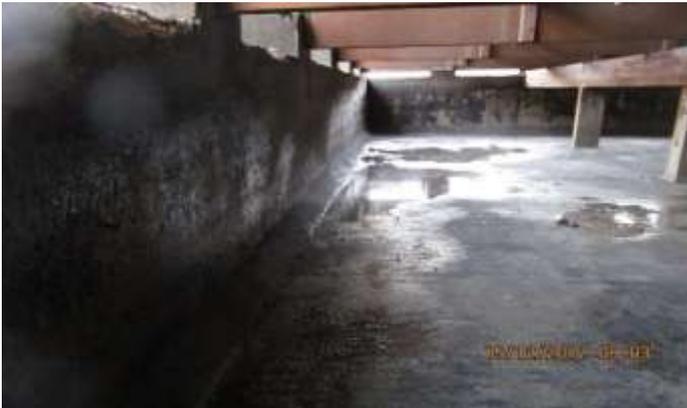
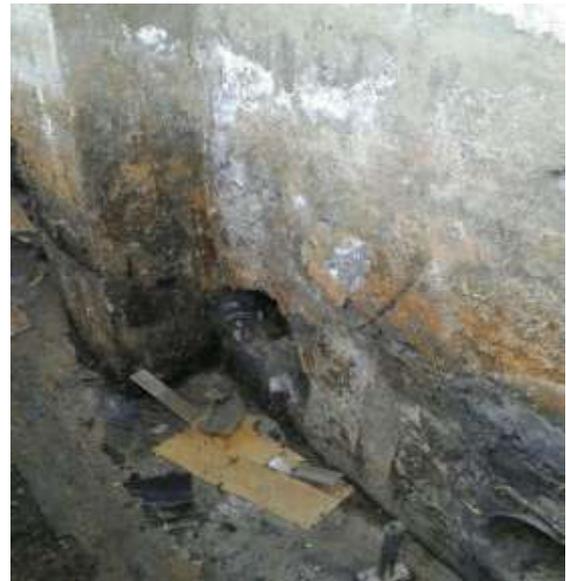
**Figure 4.7. Pianacce Power Plant pathology details.**

The works concern the basin of the Unit 3 of the Pianacce cooling tower and it consisted of the remaking of the bituminous coating, after localized restoration of the concrete and sealing of construction joints between foundation and elevation.

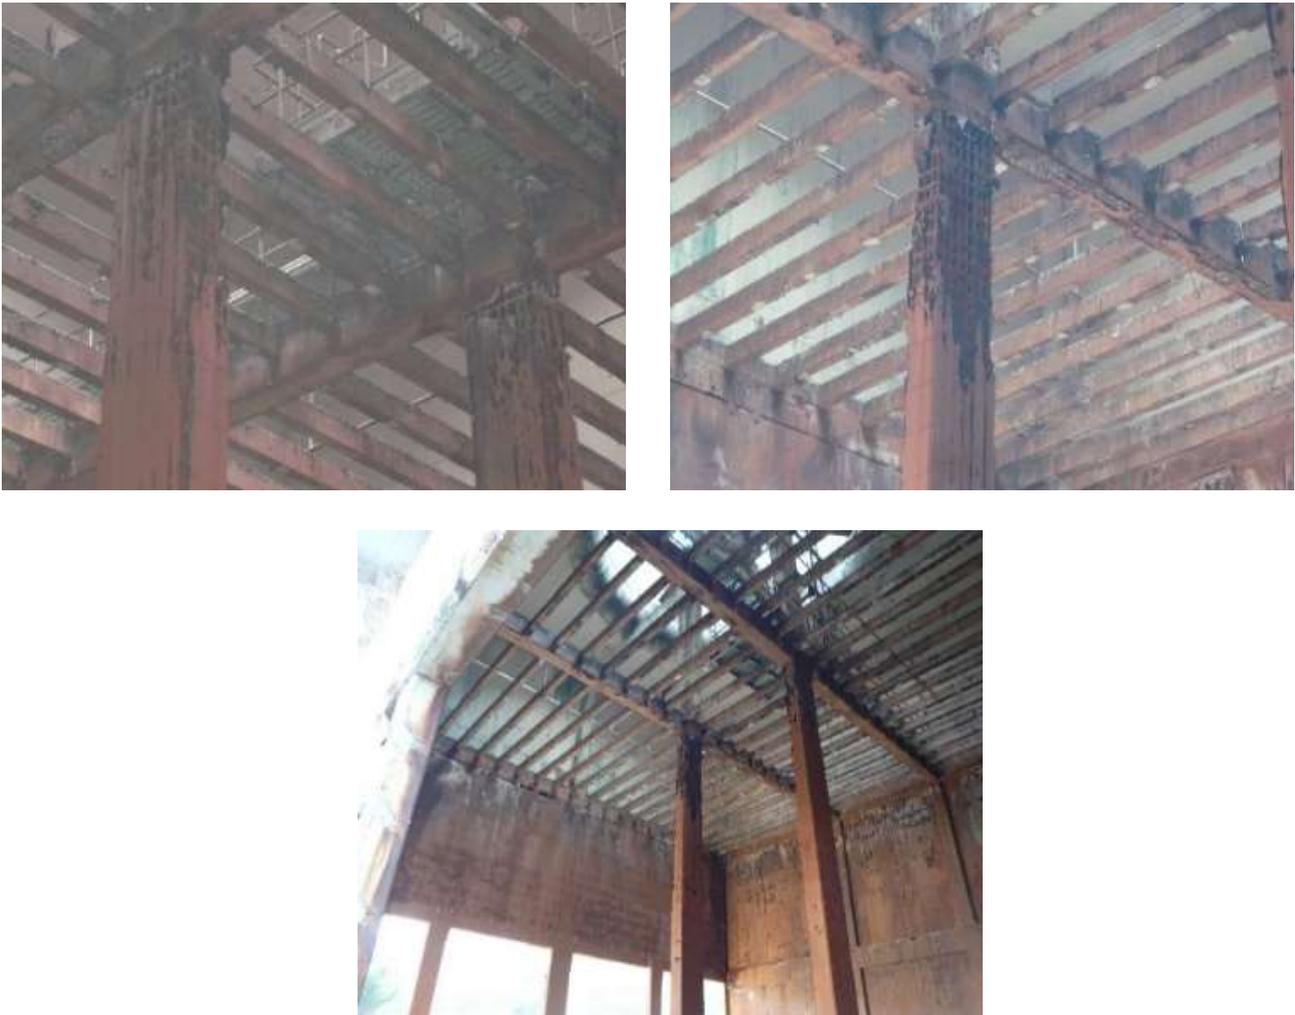
**Figure 4.8. Farinello Power Plant pathology details**

After that, additional works have been done to restore degraded concrete of the walls and beams, by means of anti-shrinkage and fiber-reinforced mortars. Similar operation was also performed in unit 4.

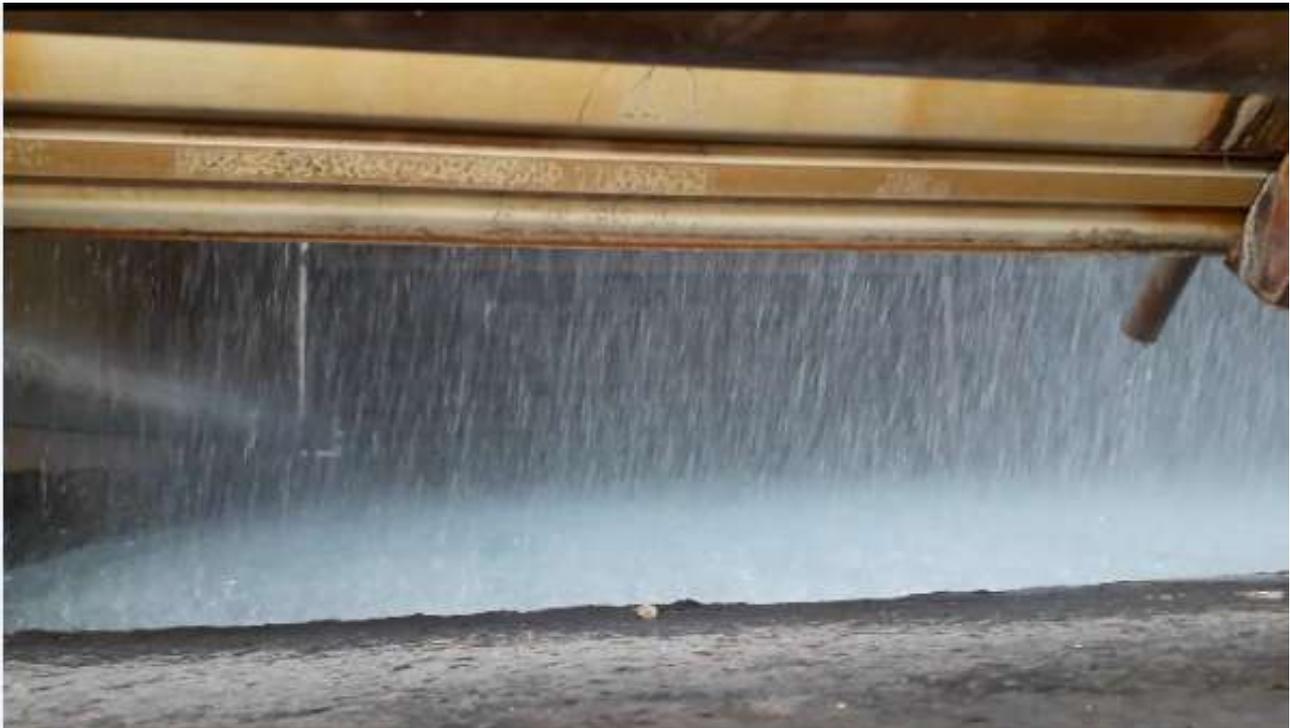
**Figure 4.9. EGP Cooling Tower Interior**

The mechanical action of the water falling down from the top of the cooling tower and the chemical aggressiveness of the environment have damaged the upper part of concrete internal walls (Figure 4.10).

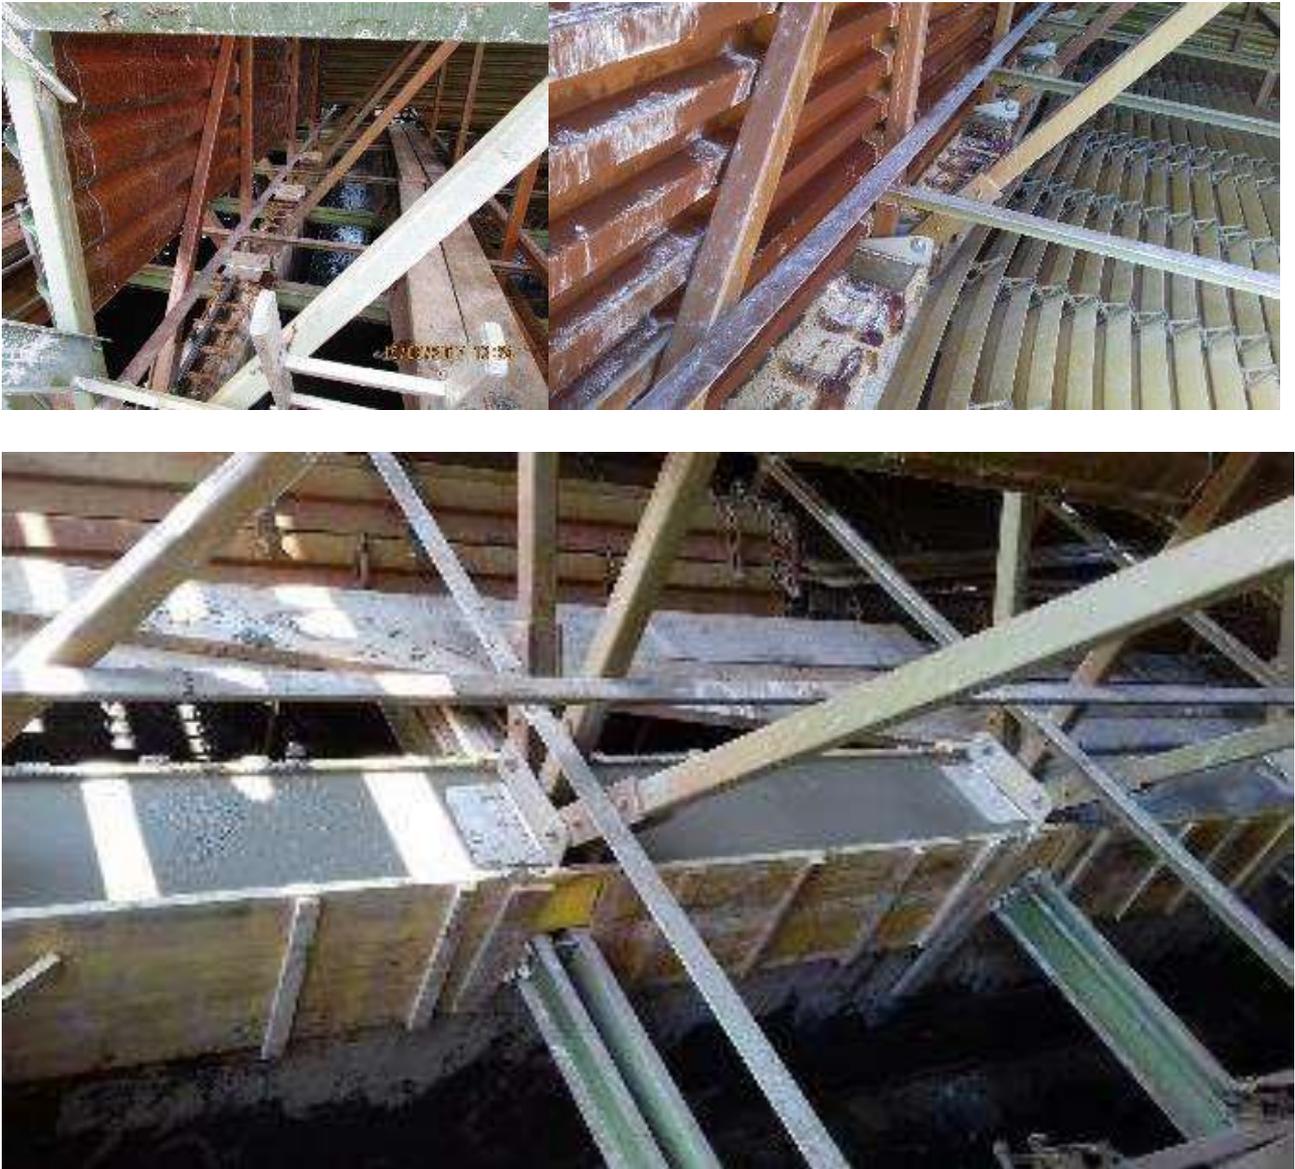
*Figure 4.10. Chiusdino Power Plant pathology details*

Finally, stainless steel flashings were placed on the head of the walls to protect the concrete from the mechanical action of the water. Considering the very limited available time it was not possible to restore the protective coating system inside the basin.

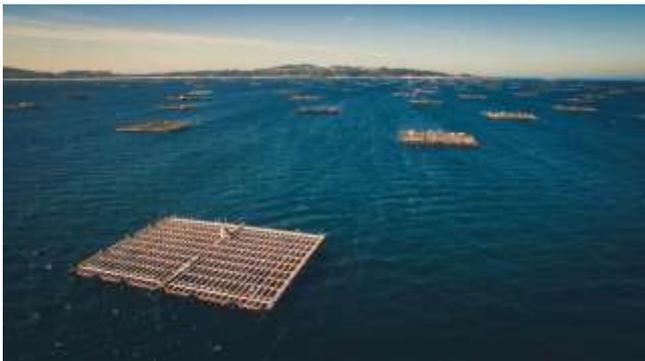
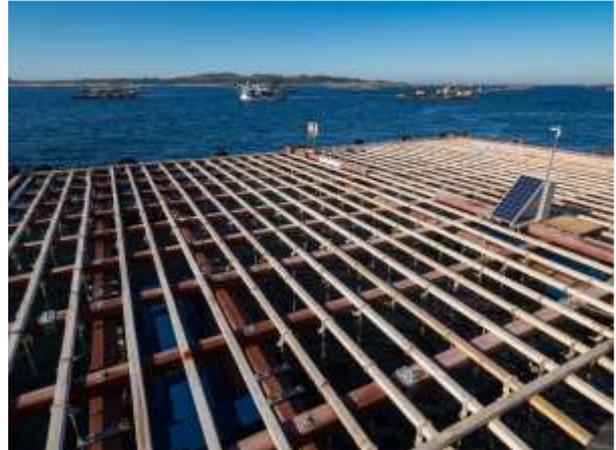
**Figure 5.6. Floating structure for RDC pilot**

Loads: The dynamics of the sea (currents and waves) and the weight of the harvest.

The pilot will be similar to the one in the picture (subjected to changes).

Section of 230 x 230 mm and others with a section of 350 mm (width) x 230 mm (depth).

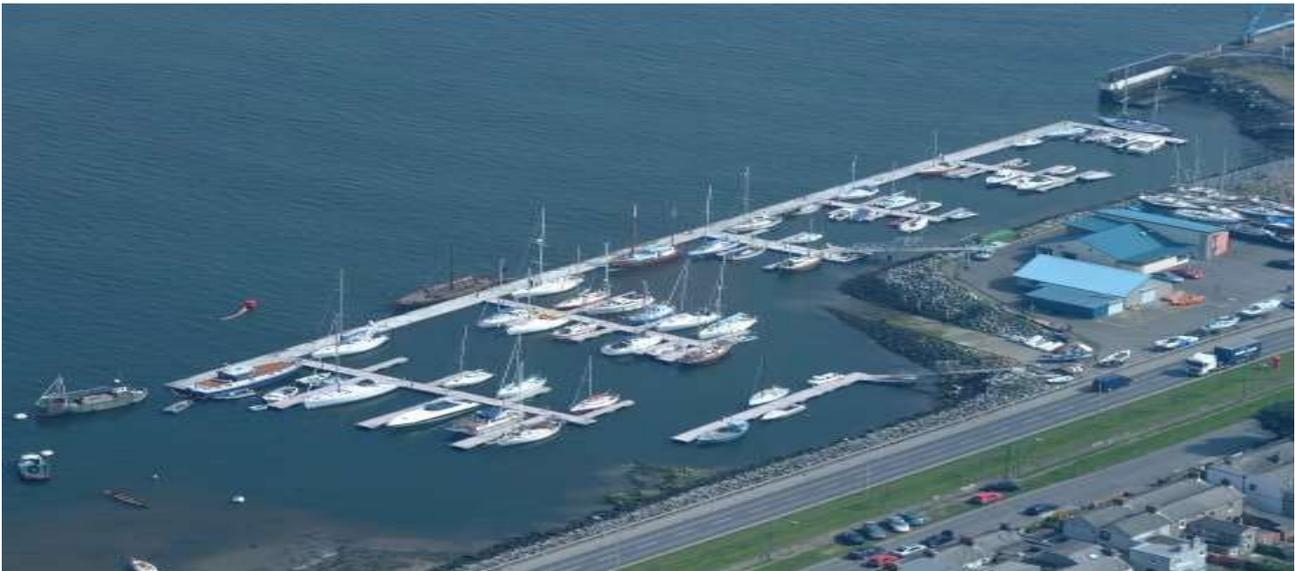
**Figure 5.7. Banagher breakwaters in Irish coast.**

It will be floating in the Pier and immersed in the Atlantic sea.

Although these demands are below a UHDC characteristics, Banagher is working in a continuous feedback with partners in WP4 to redesign the pilot with an UHDC.

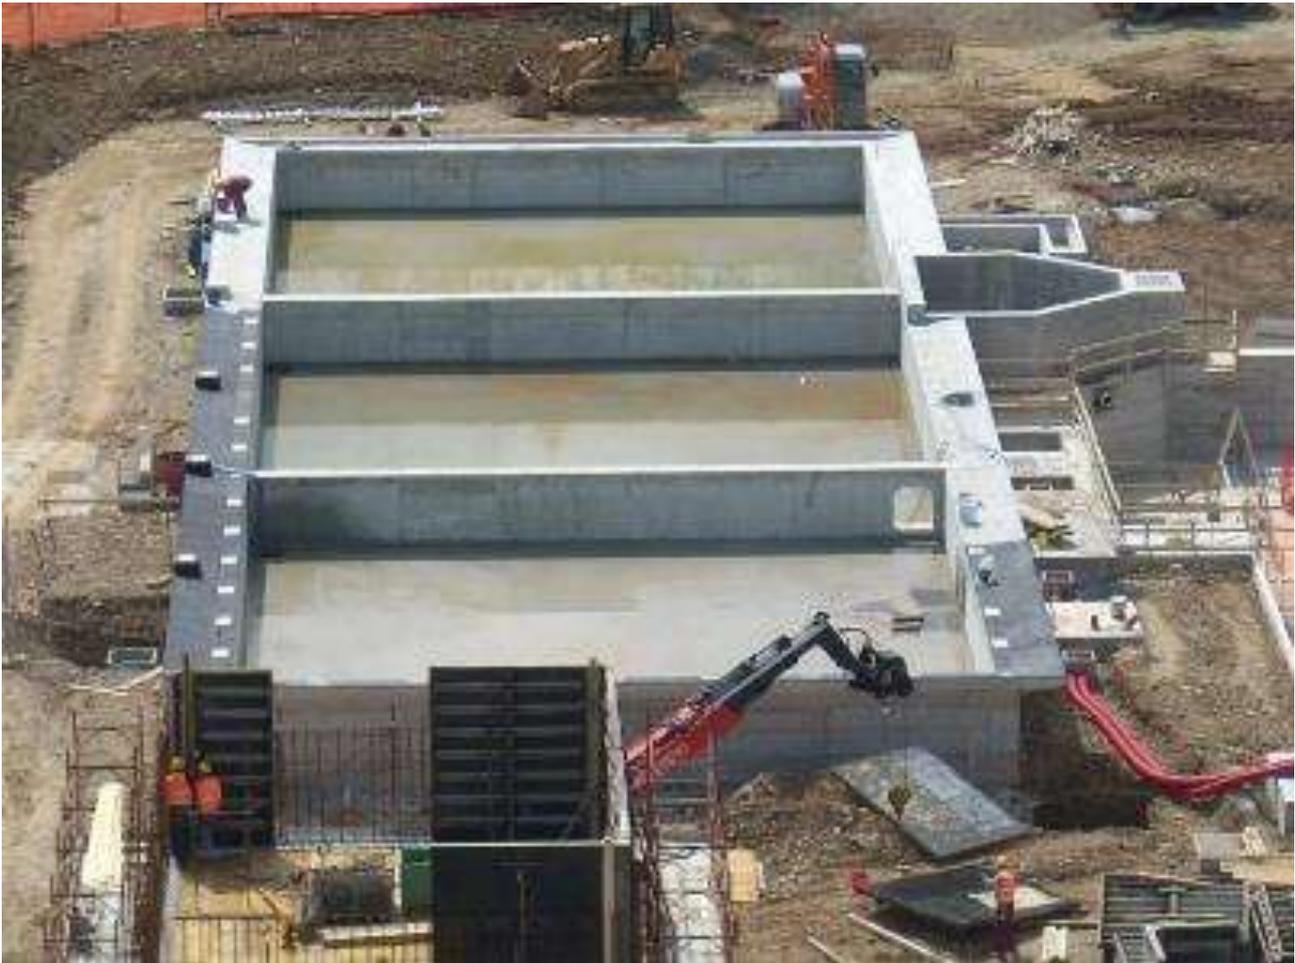
**Figure 5.10. EGP concrete basins**

There is the risk of chemical attack due to the presence of geothermal water inside the basin. The pilot is similar to the one in the picture (small-scale) (Figure 5.10).

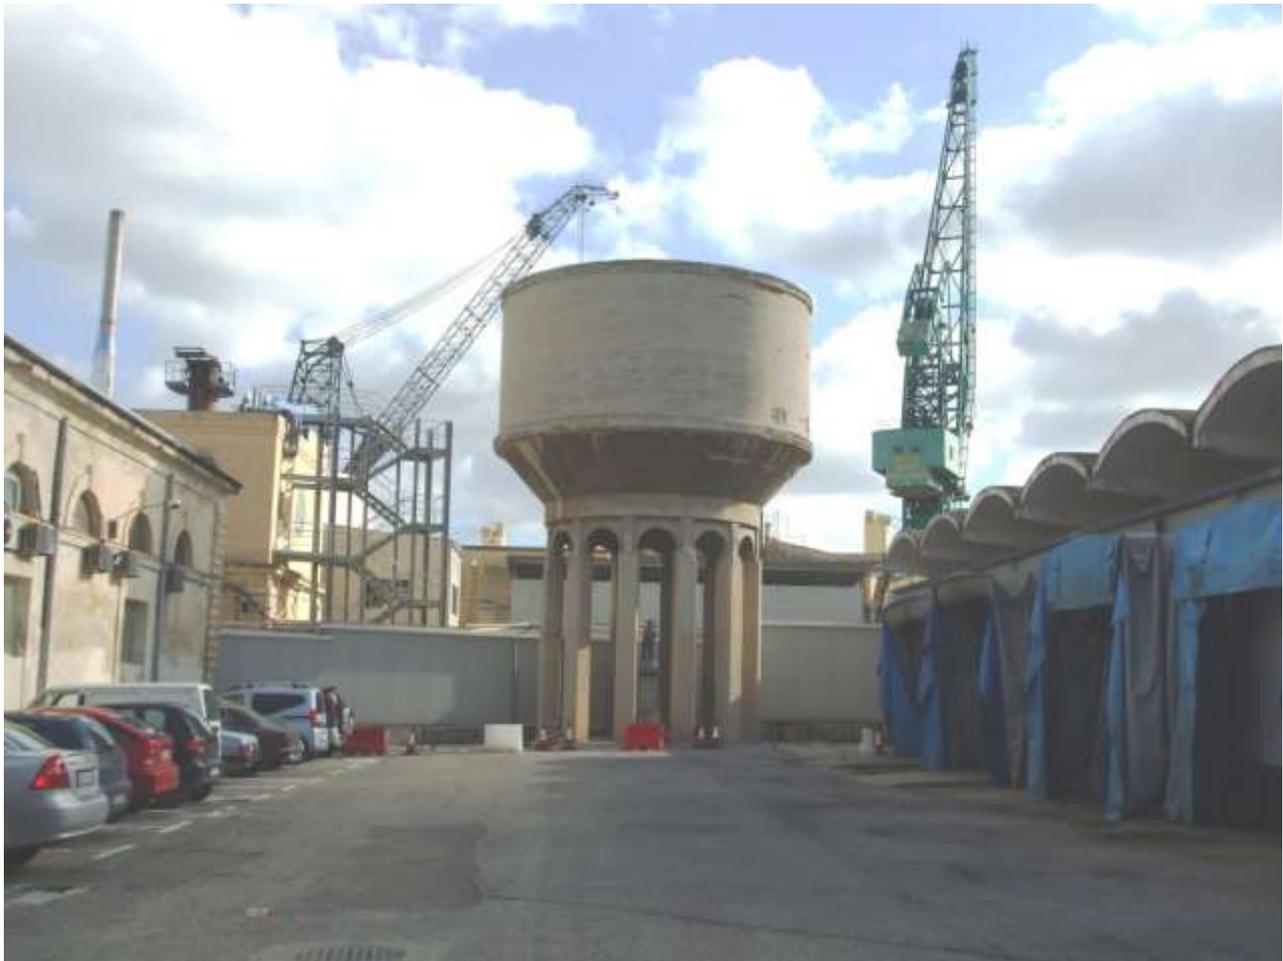
**Figure 5.12. Reinforced Concrete Water Tower (Malta).**

The reinforced concrete water tower was constructed during the first half of the 20th century to serve the water supply requirements of the Civil Abattoir ([Figure 5.12](#)). It suffered severe degradation mainly on the side exposed to the sea due to combined chloride rich environment and erosion. It consists of a reinforced concrete structure, cast in situ. The reservoir consists of a drum, open at the top with the lower part consisting of a conical structure and a dome, resting on a ring beam at the top of 12 columns supported on a base. The columns had been encased in a reinforced concrete outer skin during past repair interventions in the second half of the 20th century. The water tower has been in a severely damaged state for a number of years, with severe degradation in specific structural elements, including the south – east external face of the upper drum and conical structure, in the reinforced concrete ring beams and in the columns. The corrosion of reinforcement in parts of the structure of the drum and the conical structure has resulted in the loss in section of about 70 mm, which amounts to about half of the thickness of the drum since the reinforcement is located in the centre of the cross-section. Concrete spalling and delamination as a result of corrosion is observed in various parts of the structure (**Errore. L'origine riferimento non è stata trovata.**) The Water Tower is considered to be a unique structure and the only one of its type in the Maltese Islands (see dimensions and sections in [Figure 5.13](#)).

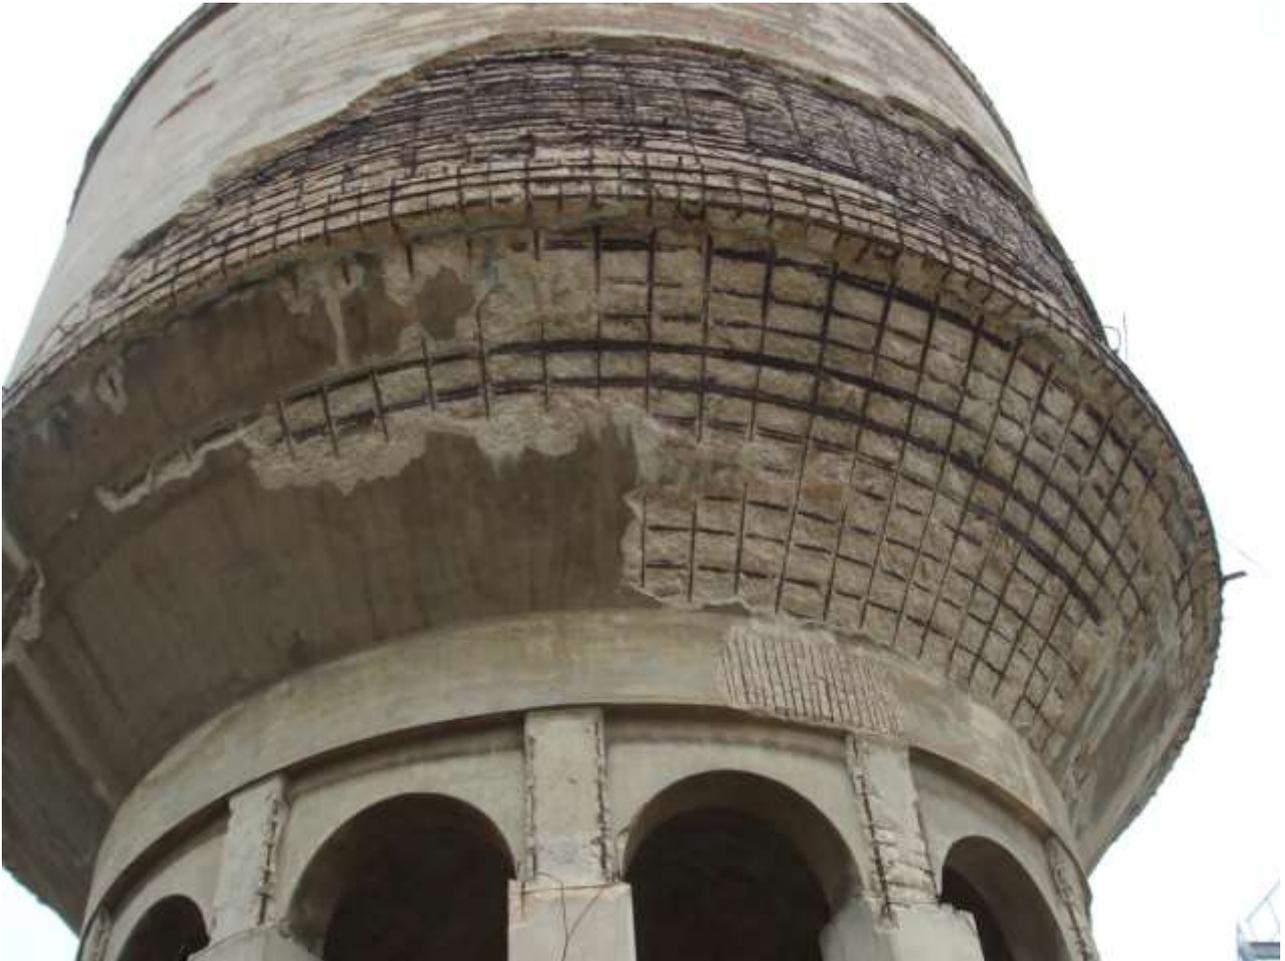
*Figure 5.14. Pathologies (spalling and delaminating) in water tower.*

- Cracks: Epoxy injection shall be used throughout in the case of cracks in the concrete, both on the external surface and also the internal surface.
- Internal Water proofing: An internal water proofing shall be applied to the top of the dome, top of the conical lower part of the tank and the internal areas of the drum. A corrosion inhibitor and sealer shall be employed on all external surfaces.
